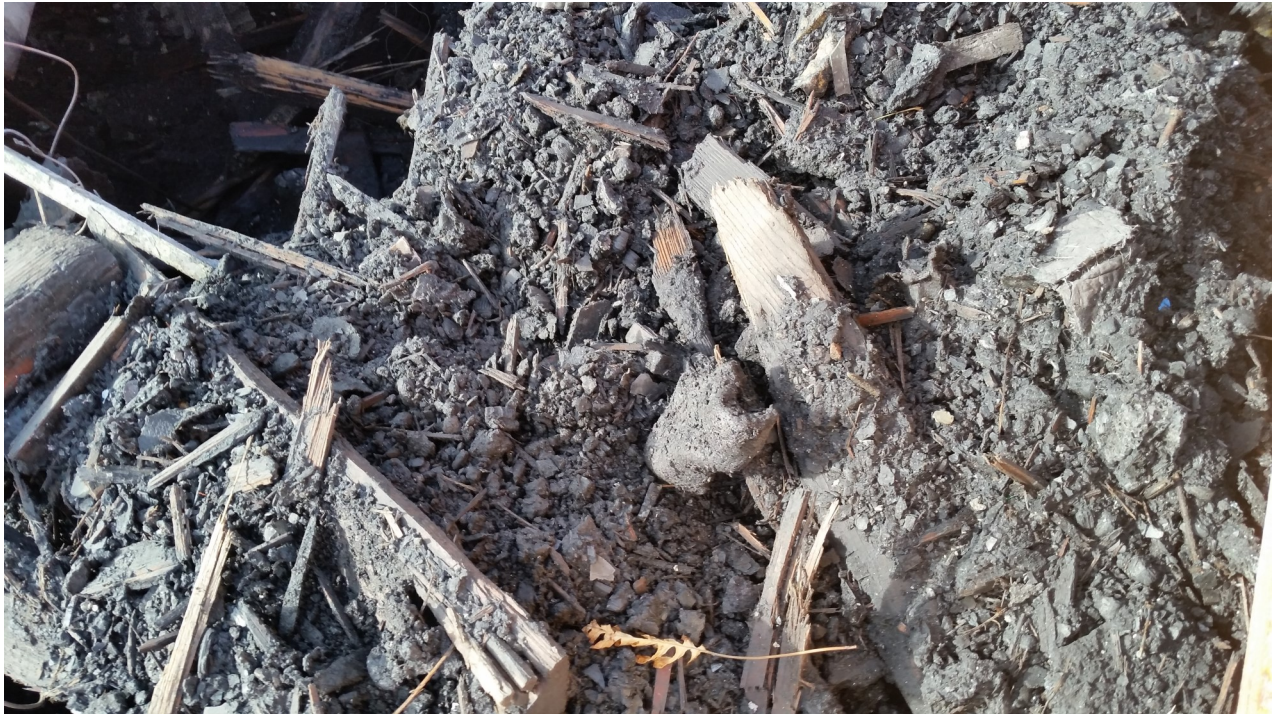
Sample --BL01BL: Ash pile remaining on top of warehouse surface after large debris removal during the emergency response. No asbestos detected by Polarized Light Microscopy.

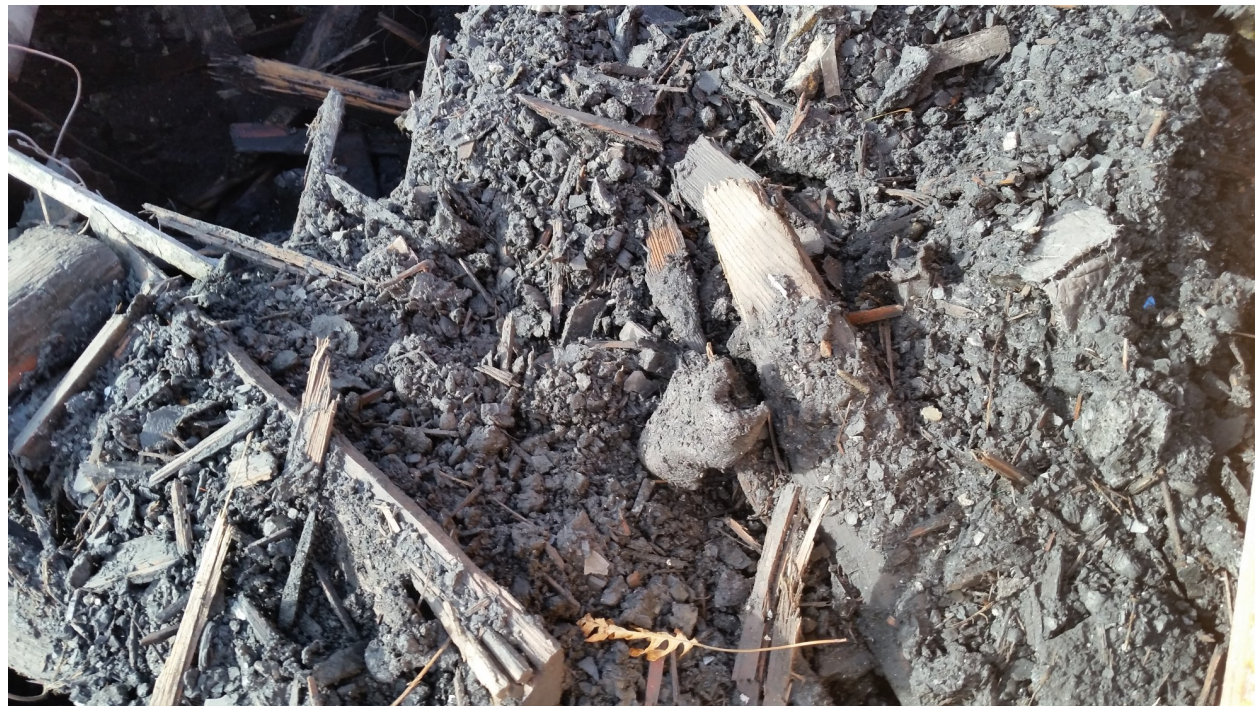
Sample -BL02BL: Potential roofing material found on top of warehouse platform. Lab detected 20% Chrysotile.

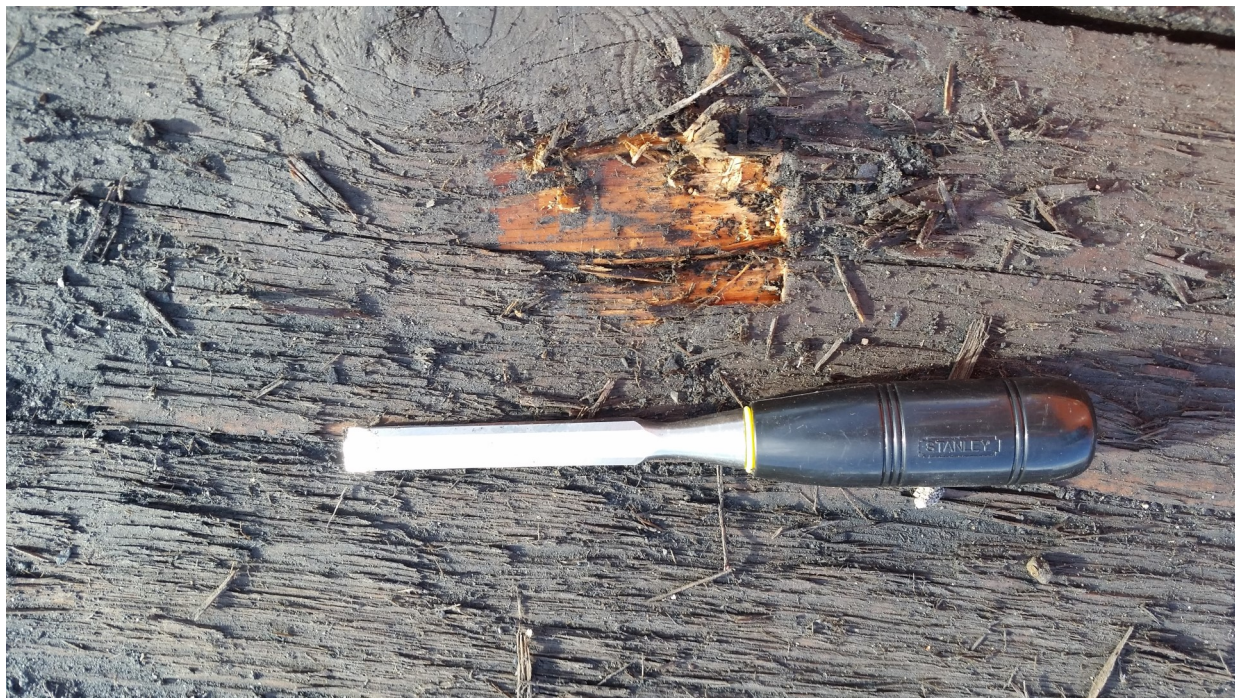
Sample -BL03BL: Exposed wood flooring under asphalt layer of warehouse platform. No asbestos detected by Polarized Light Microscopy.

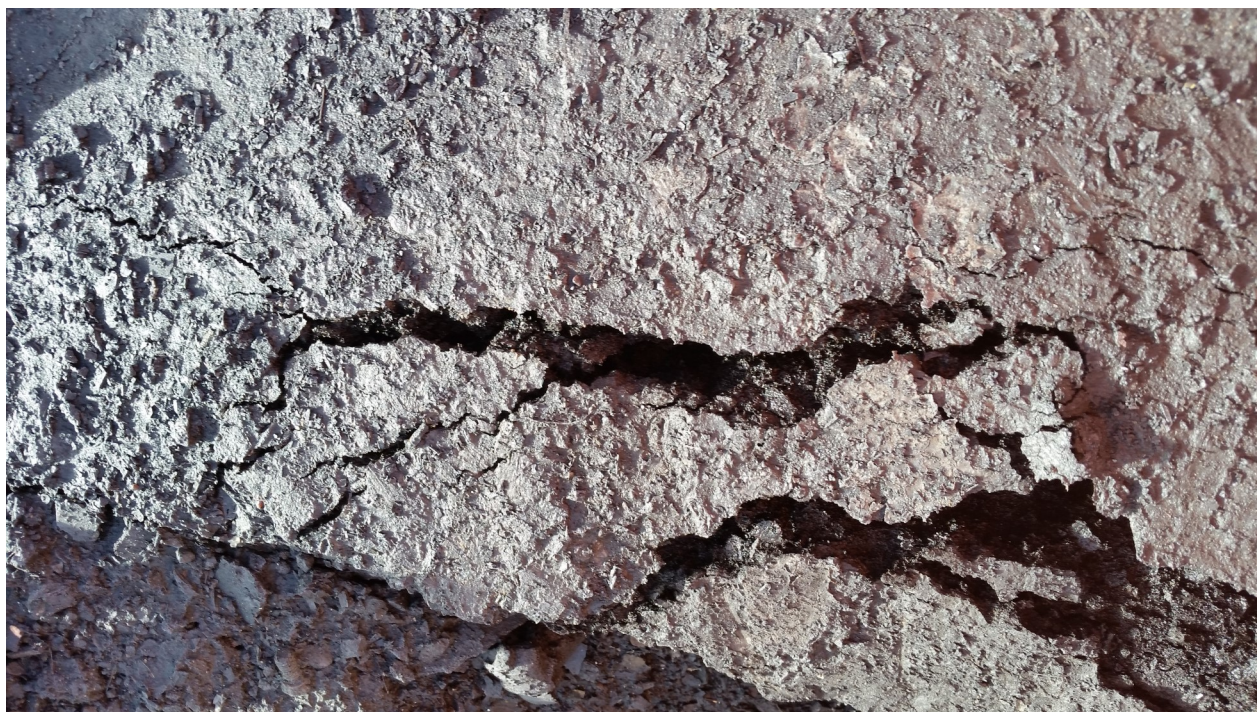
Sample -BL04BL: Asphalt layer of warehouse platform. No asbestos detected by Polarized Light Microscopy.

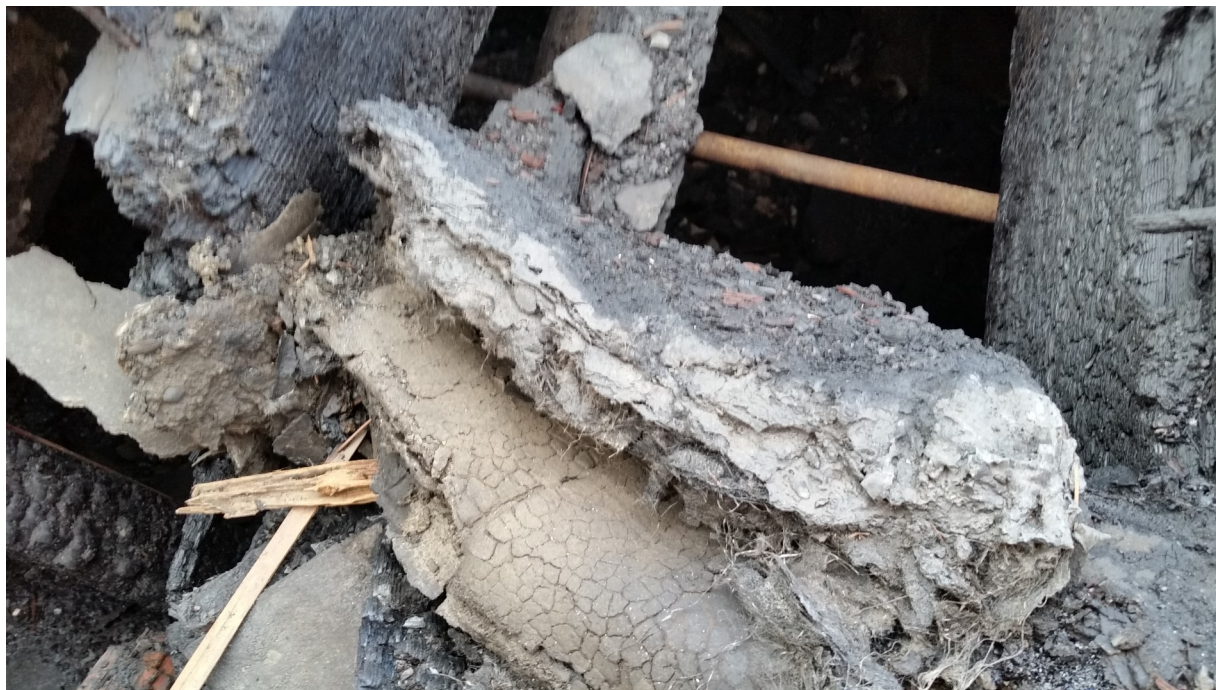
Sample -BL05BL: Potential vapor barrier material 1, found in exposed wood beams under asphalt. Lab detected 35% Chrysotile.

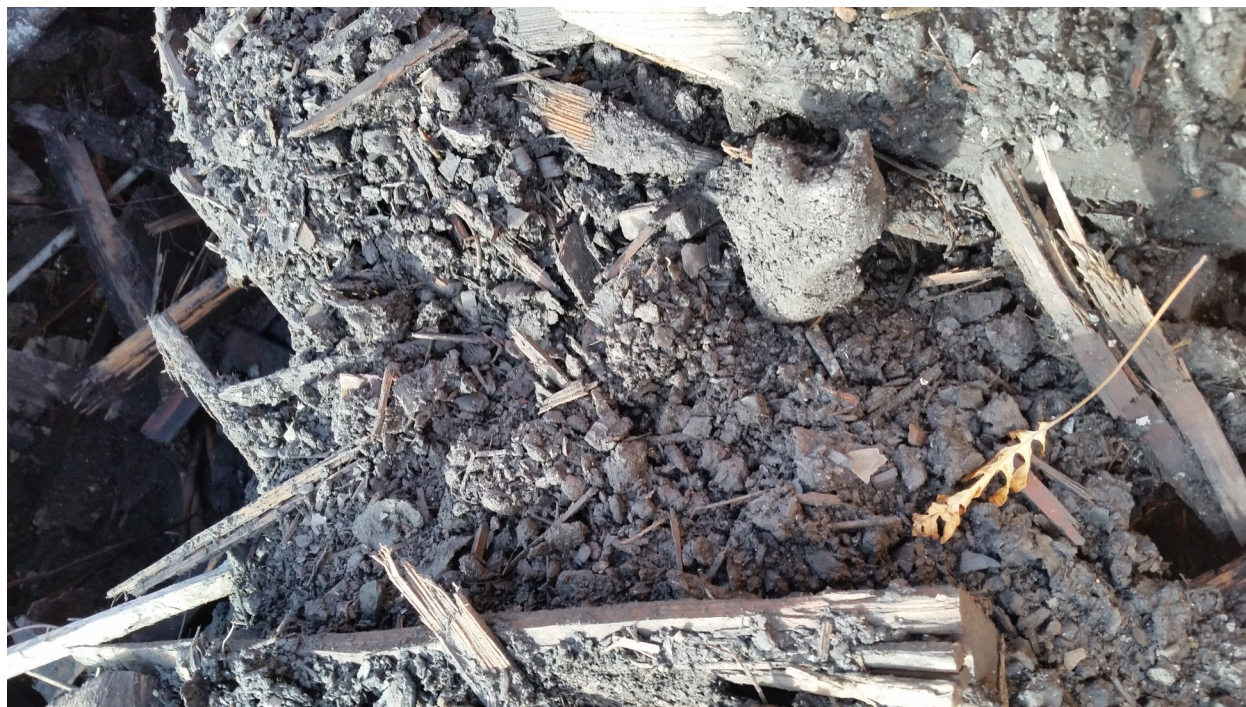
Sample -BL06BL: Ash pile remaining on top of warehouse surface after large debris removal during emergency response. Lab detected 2% Chrysotile.

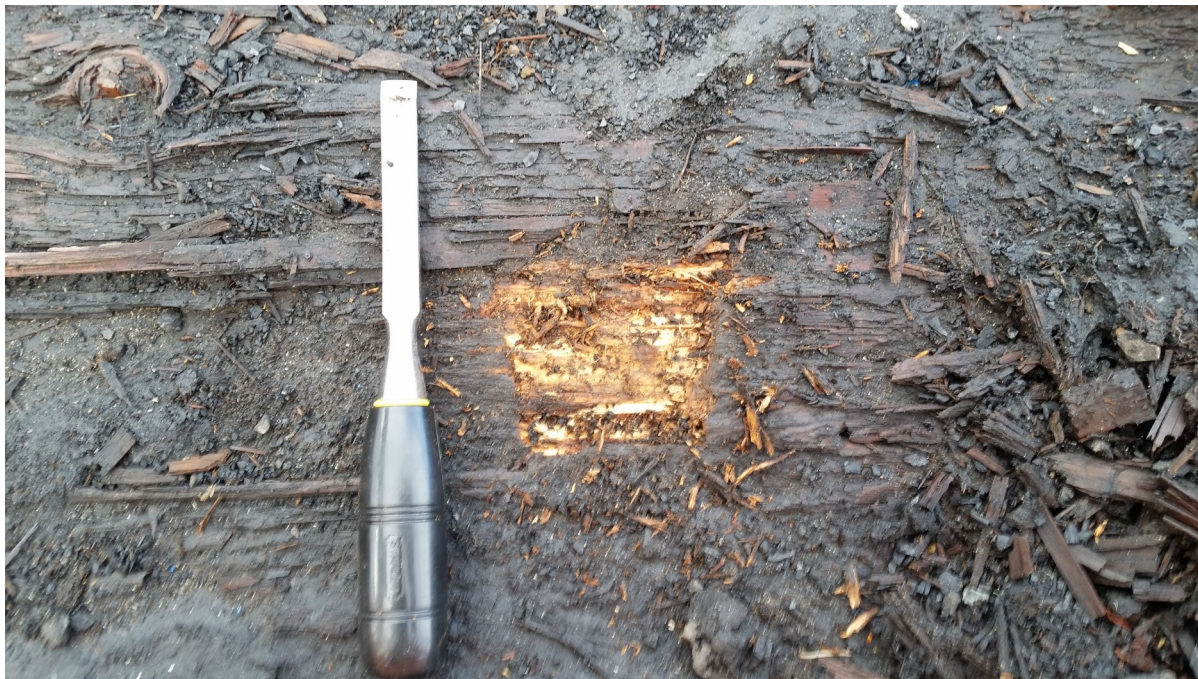
Sample -BL07BL: Exposed wood flooring beneath asphalt layer of warehouse platform. No asbestos detected by Polarized Light Microscopy.

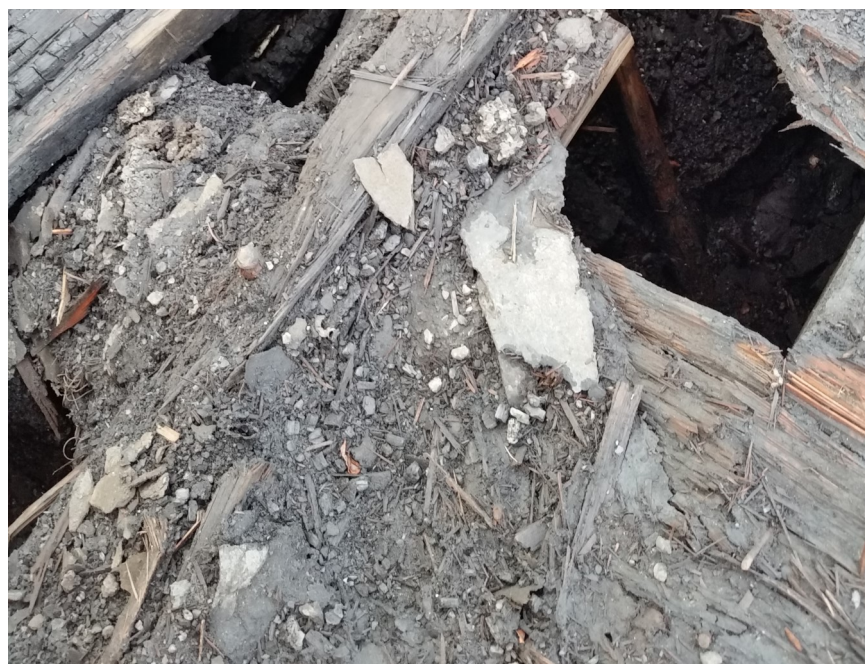
Sample -BL08BL: Potential vapor barrier #2, found on top of warehouse platform. No asbestos detected by Polarized Light Microscopy.

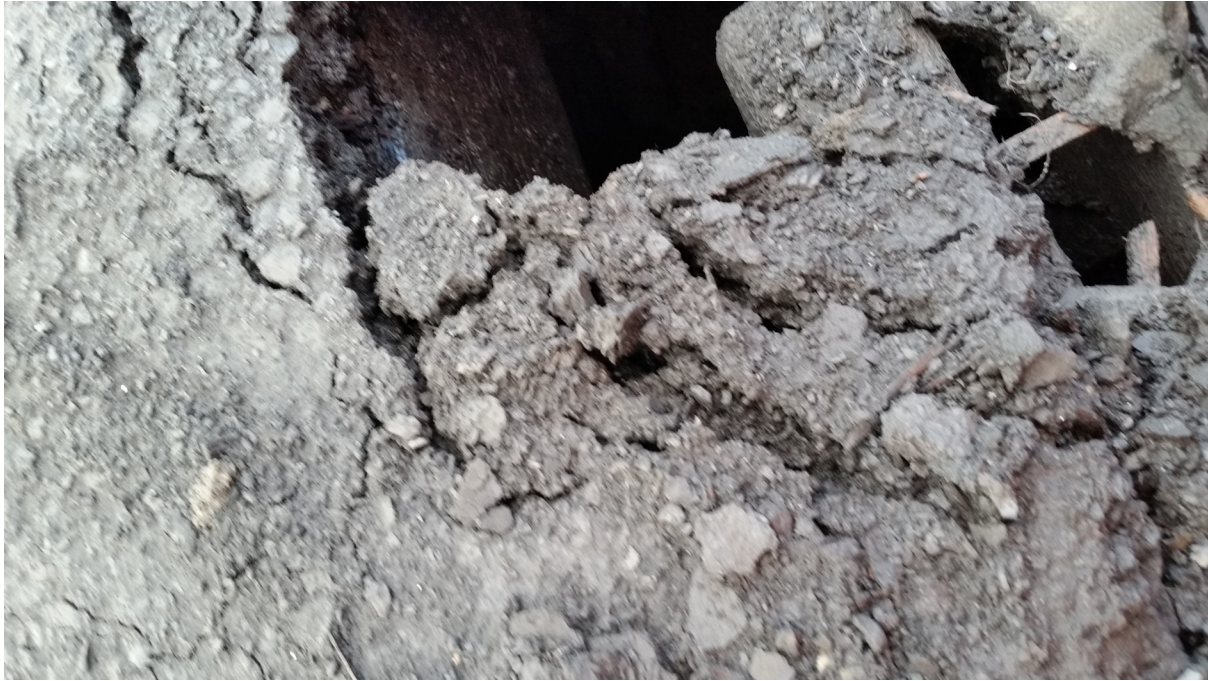
Sample -BL09BL: Asphalt layer of warehouse platform. No asbestos detected by Polarized Light Microscopy.

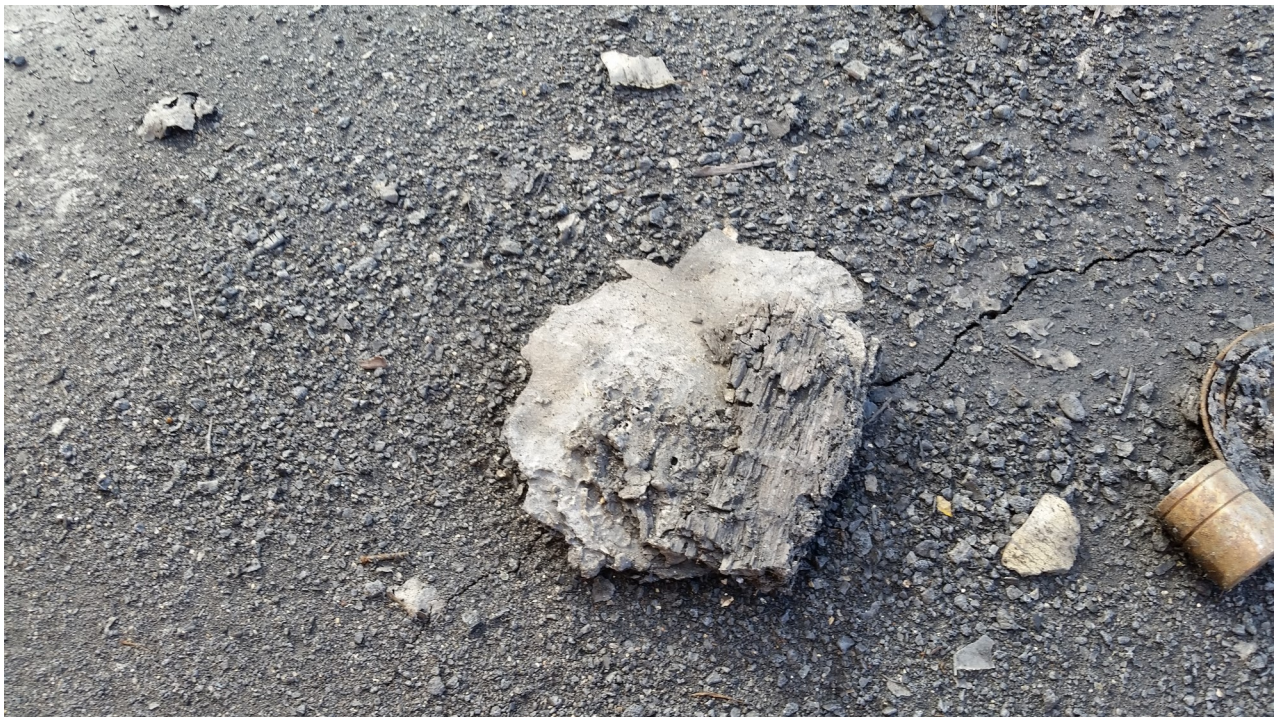
Sample -BL10BL: Potential vapor barrier caked on top of warehouse asphalt after large debris removal during emergency response. No asbestos detected by Polarized Light Microscopy.

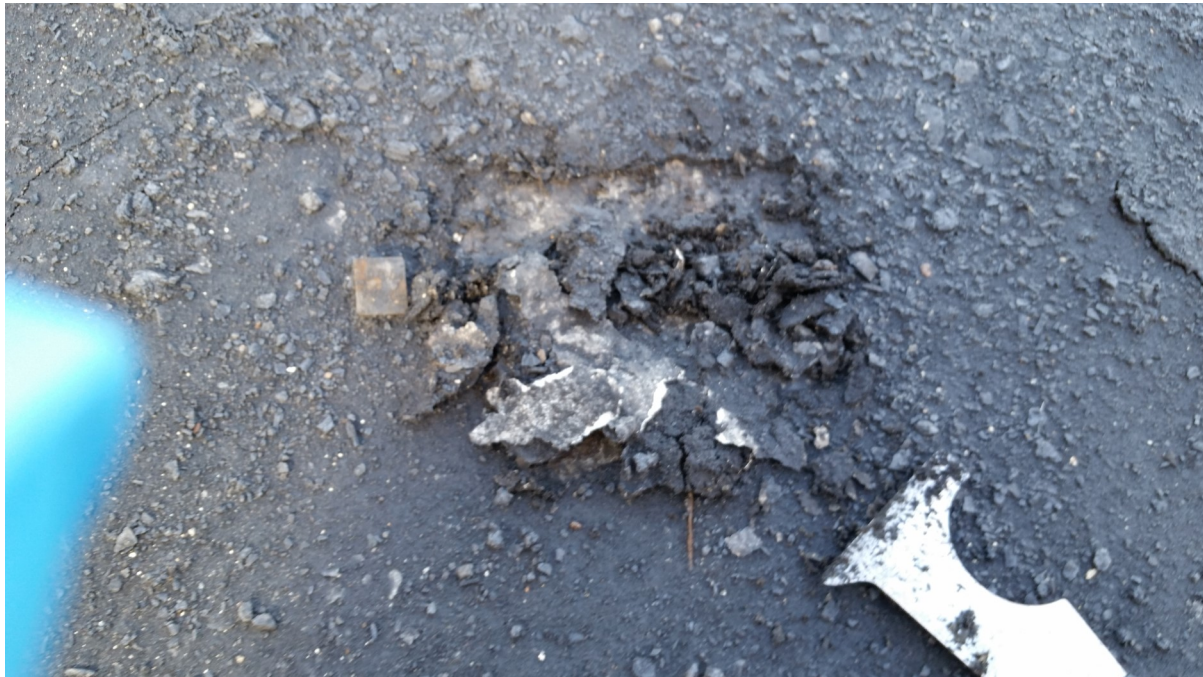
Sample -BL11BL: Top of asphalt/ash pile remaining on top of warehouse after large debris removal during emergency response. No asbestos detected by Polarized Light Microscopy.

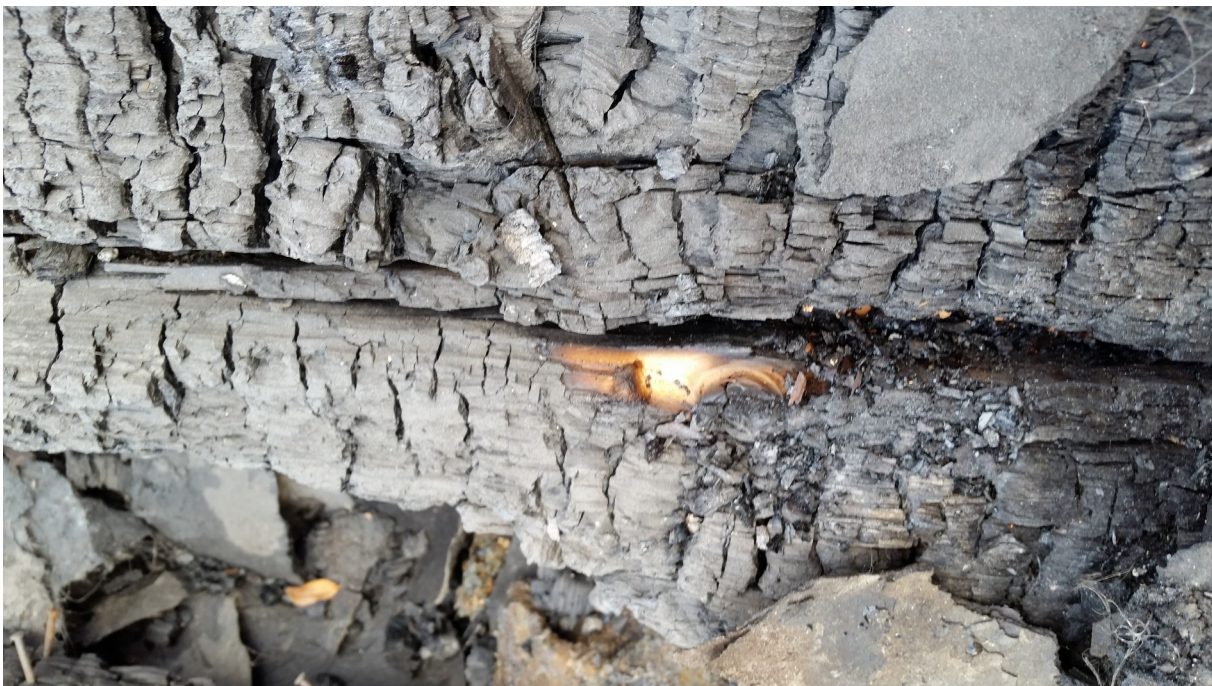
Sample -BL12BL: Burned wood piling from frame of warehouse structure. No asbestos detected by Polarized Light Microscopy.

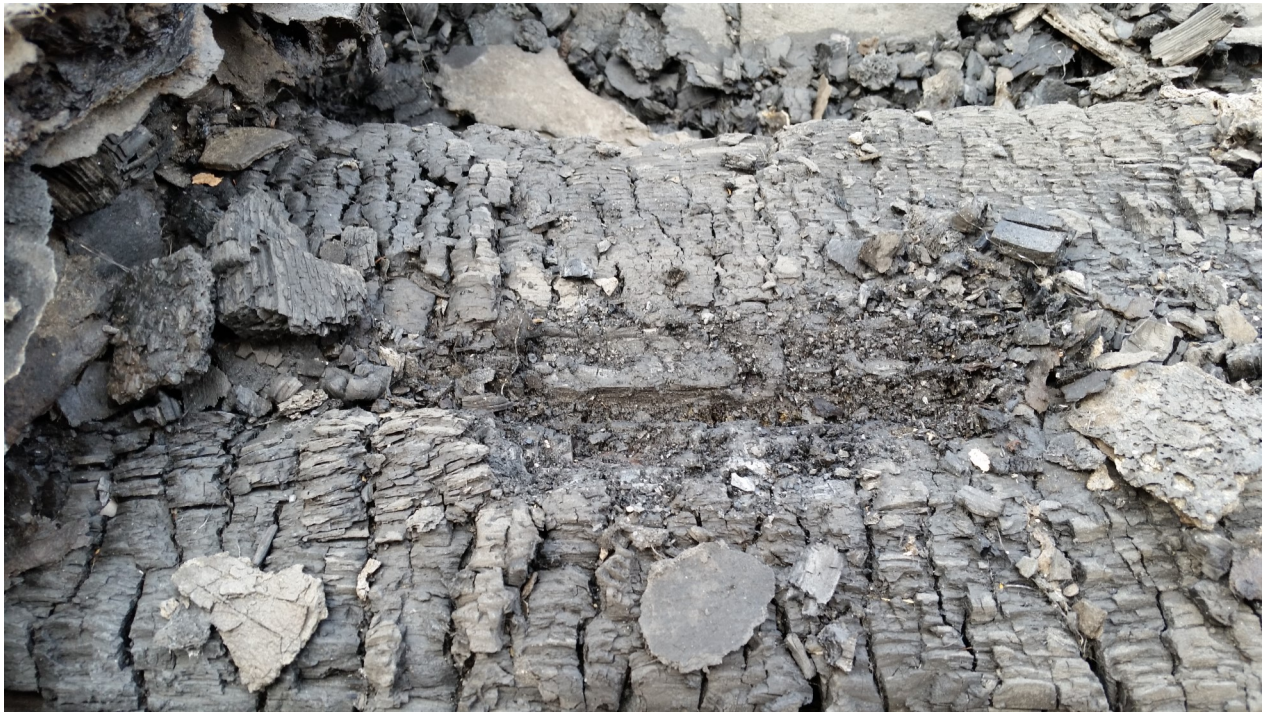
Sample -BL13BL: Burned wood piling from frame of warehouse structure. No asbestos detected by Polarized Light Microscopy.

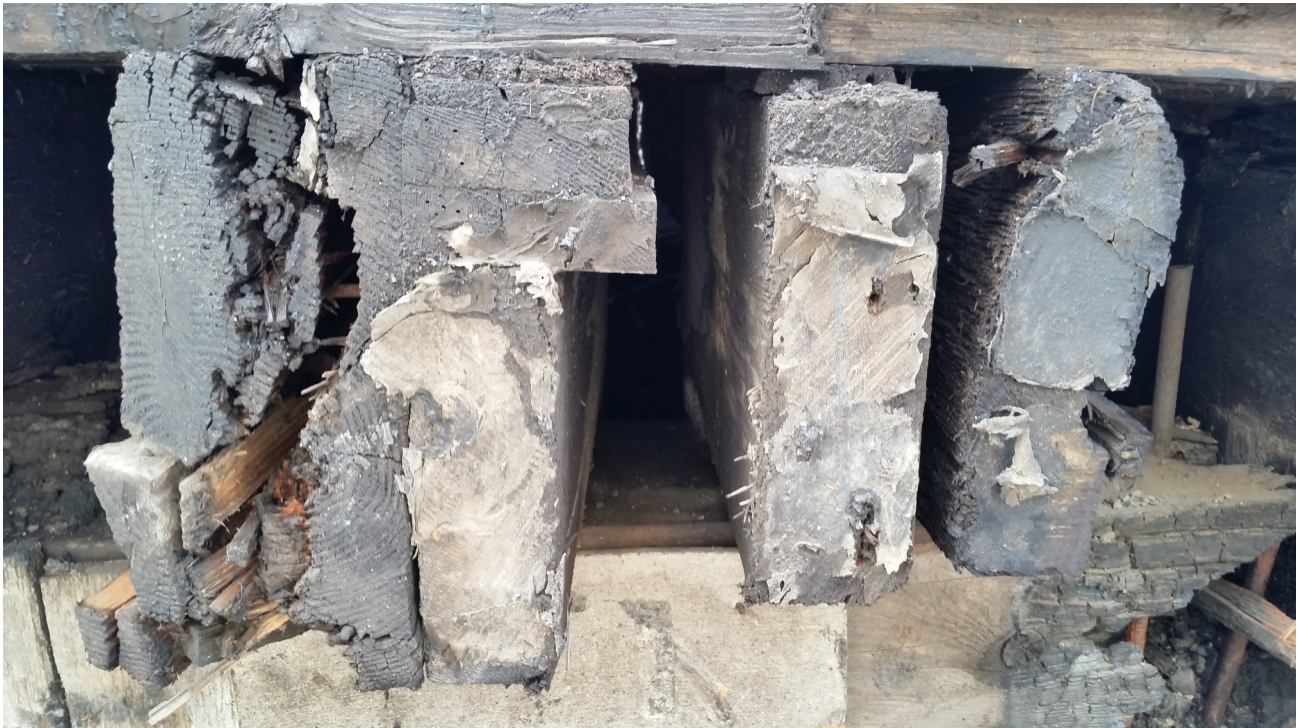
Sample -BL16BL: Close up of suspicious material collected from face of the wood under asphalt warehouse platform. Lab detected 3% Chrysotile.

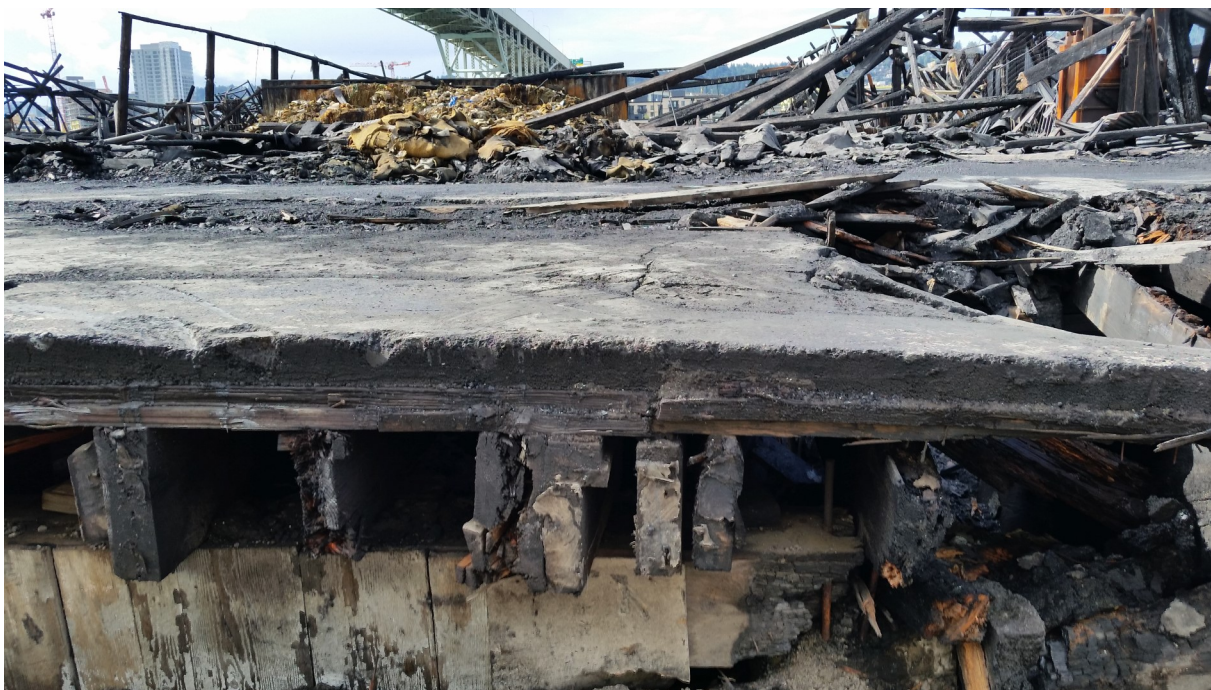
Sample BL16BL: Location of sample BL16 along edge of warehouse platform, facing cell A11.

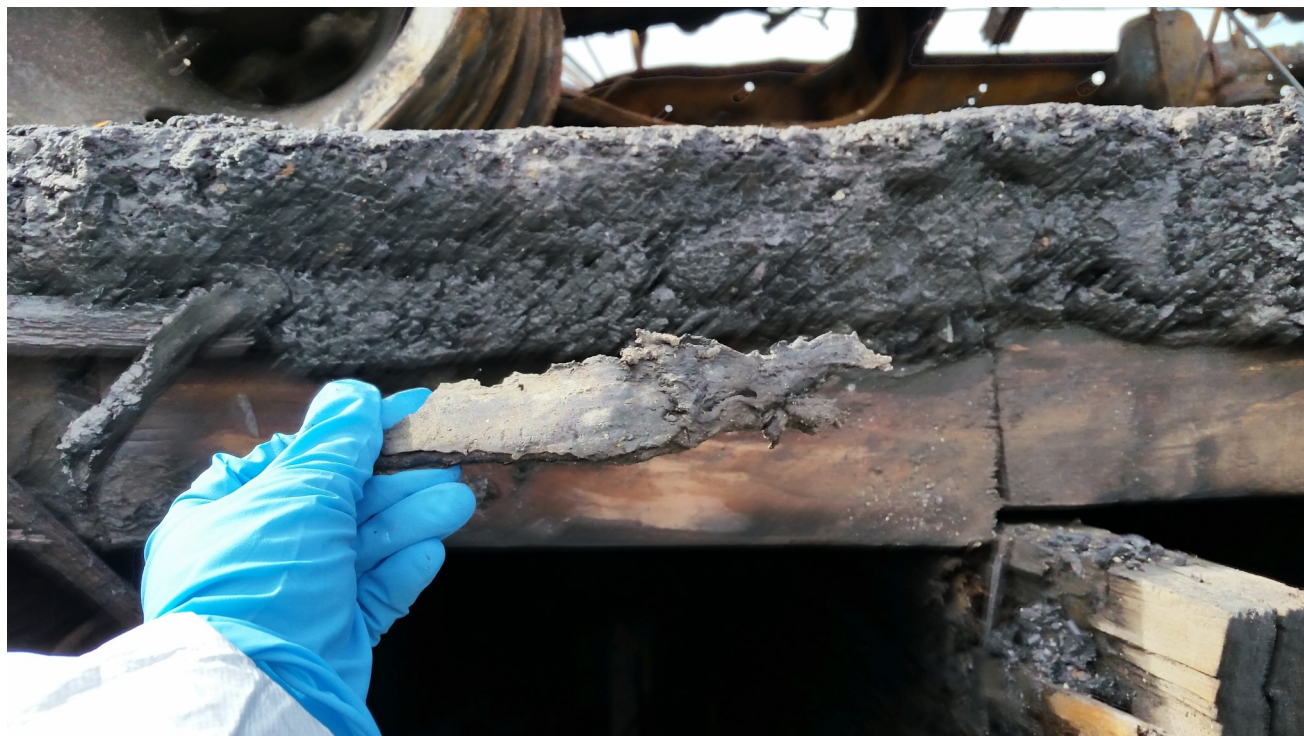
Sample -BL17BL: Suspicious material found between asphalt layer and wood on warehouse platform. Lab detected 5% Chrysotile.
